# **Factual Report**

**Fire Aboard Construction Barge *Athena 106*  
West Cote Blanche Bay, Louisiana  
October 12, 2006**

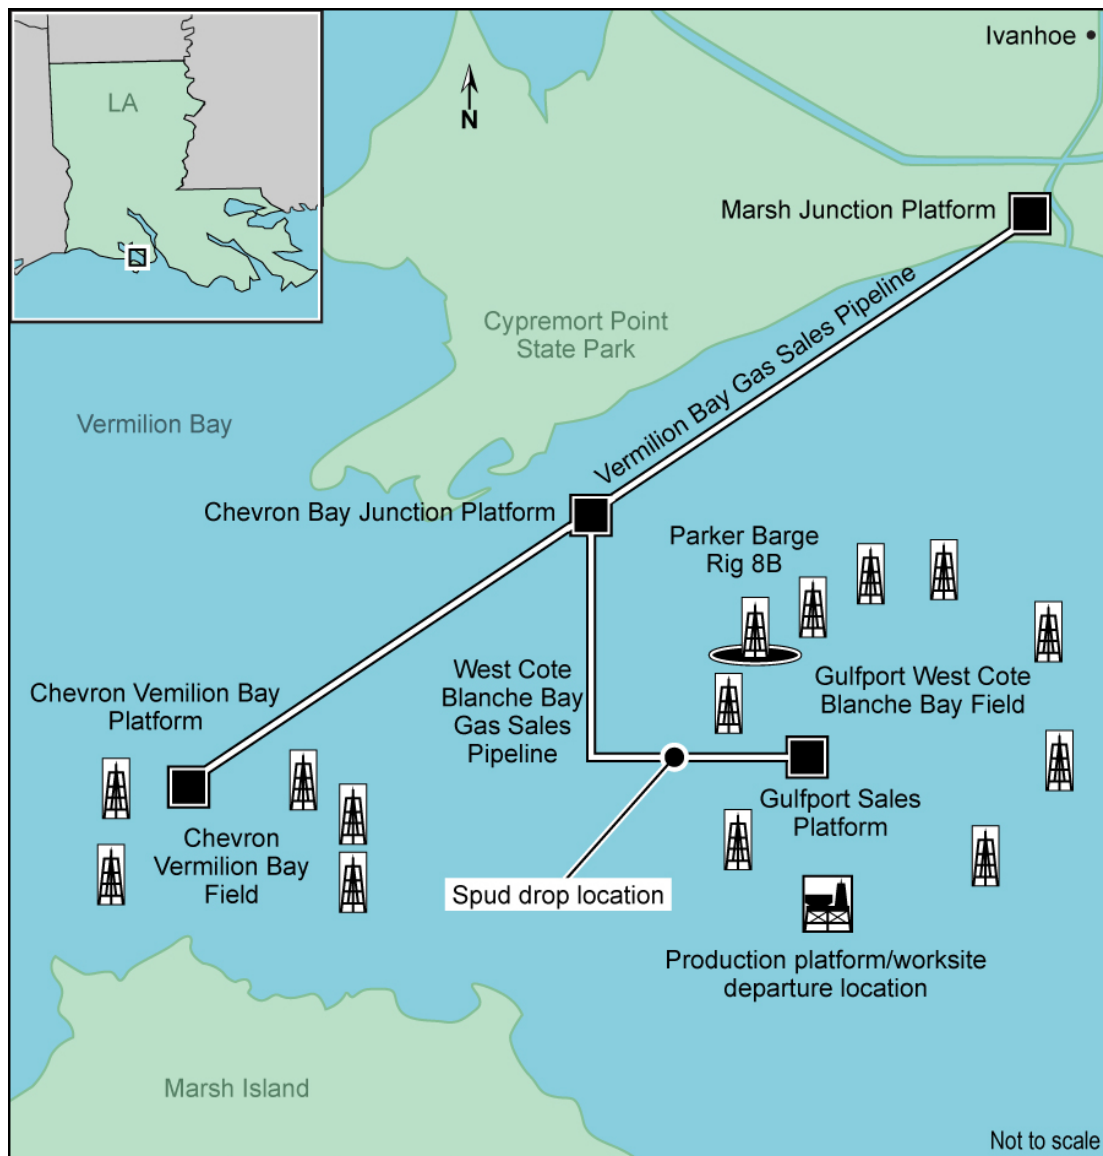
**Figure 1.** Site where construction barge *Athena 106* dropped a 5-ton mooring spud on the West Cote Blanche Bay natural gas sales pipeline. The pipeline carried excess natural gas from the Gulfport sales platform (where extracted natural gas was processed and injected back into oil-producing wells to aid in oil production) to a junction with Chevron's Vermilion Bay gas sales pipeline. The pipeline between the Gulfport sales platform and the Chevron bay junction platform was about 19,650 feet long. The pipeline between the Vermilion Bay platform and the bay junction platform was about 32,300 feet long.

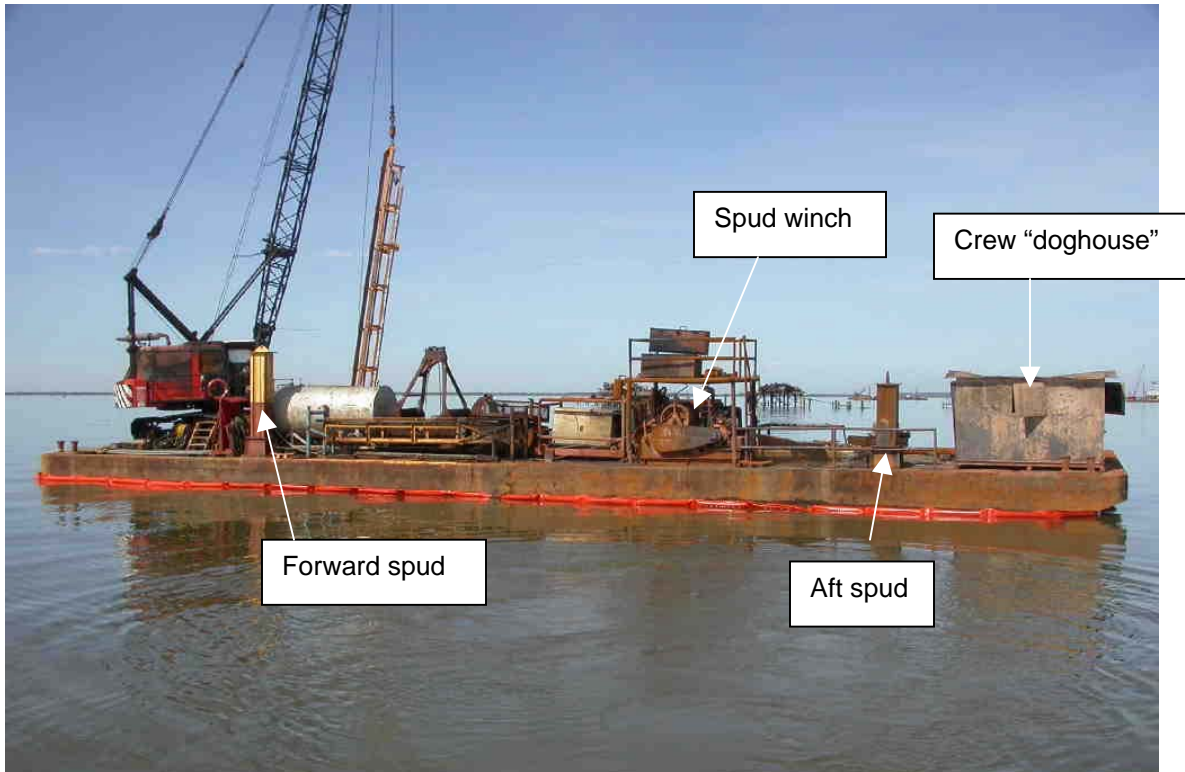
**Figure 2.** *Athena 106* after the fire. The construction barge was equipped with two mooring spuds (shown in the lowered position), both on the port side, one forward and one aft, controlled by a single winch. At the front of the barge was the crane used to hoist and position pilings for driving or to maneuver them to a barge alongside for storage.

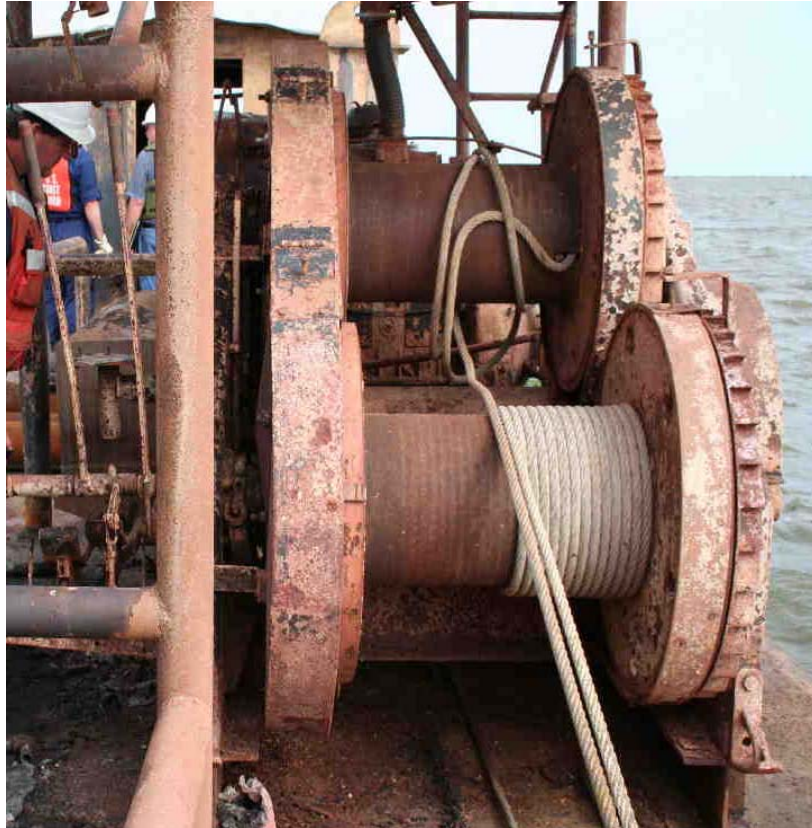
3         The spud winch operator said that he wondered what had caused the spud to drop,  
4 looked at the winch, and saw no one near it who might have accidentally released the  
5 brake. He noticed that the cable on the upper drum connecting the aft spud to the winch  
6 was fouled (“birdnested like [the reel on] a fishing pole”) on the drum (**figure 6**). The  
7 spud winch operator said that he then saw a large “burst” in the water alongside the barge  
8 “right where the [aft] spud was.” He was looking toward the towboat behind the barge  
9 when a large fireball erupted between the aft end of the *Athena 106* and the towboat, with  
10 “flames and water . . . going everywhere.” The fire engulfed the *Miss Megan*. By that  
11 time, the barge’s crane operator was beside the spud winch operator and told him to run  
12 to the front of the barge, where the crane was stationed. The spud winch operator did not

**Figure 6.** Photo showing cable “birdneste” on the winch drum (upper rear) that led to the *Athena 106*’s aft spud. The cable on the lower winch, which led to the forward spud, is properly wound.

6 **Athena 106.** Investigators found both the forward and aft spuds on the *Athena*  
7 *106* in the lowered position (as noted below, they were informed by the recovery crew  
8 that the forward spud had been in the raised position until it fell during the recovery  
9 effort). The 7/8-inch steel cables connecting the spuds to the barge's winch were  
10 examined for signs of preexisting damage and found to be free of any fraying or other  
11 visible defects. The cable leading from the winch to the forward spud exhibited a light  
12 strain condition, with its remaining turns wrapped uniformly around the lower winch  
13 drum. The cable connecting the aft spud to the winch was found completely fouled on the  
14 upper winch drum, or "birdnested," with none of its remaining cable turns on the drum  
15 still wrapped on the inner drum surface (see **figure 6**).

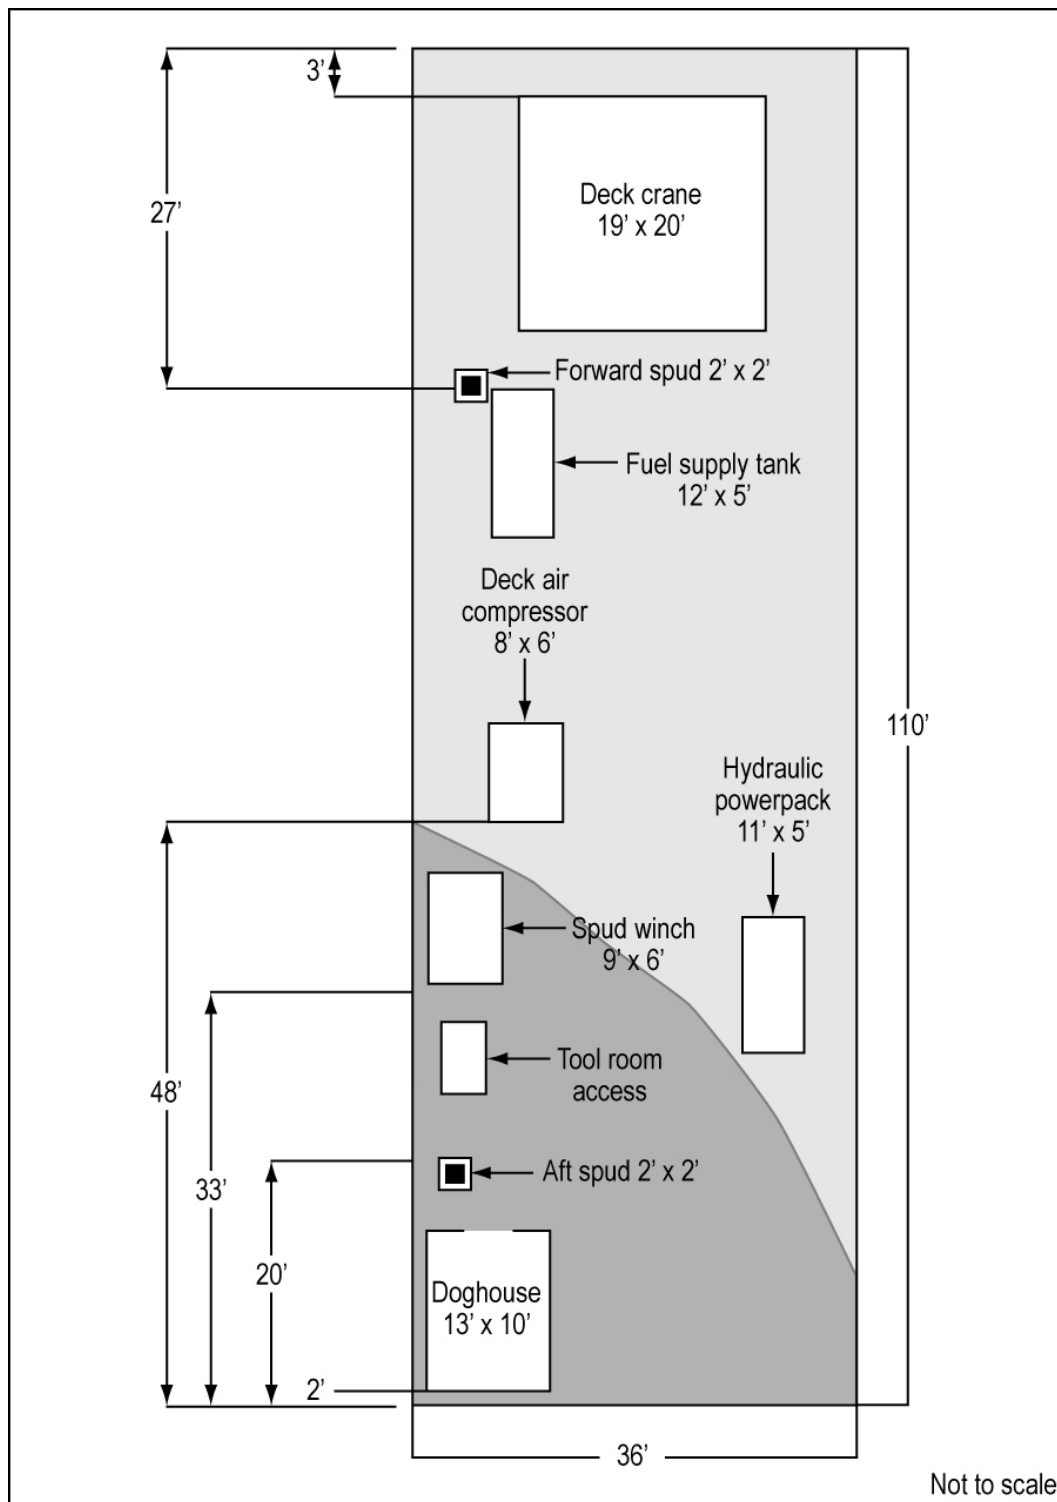
1  
2 **Figure 7.** General layout of *Athena 106* construction barge. Fire damage to equipment  
3 on the barge deck was greatest in the dark-shaded area.

12         The barge suffered the greatest damage on its port side and aft end, where the fire  
13 severely damaged the doghouse, the deck generator, the deck air compressor, and the  
14 spud winch. Some small portable equipment and hand tools in the area, such as a  
15 chainsaw, were also consumed by the fire. Several oxygen and acetylene bottles used by  
16 the crew in their day-to-day operations had exploded from the heat of the fire and were  
17 strewn about the deck.

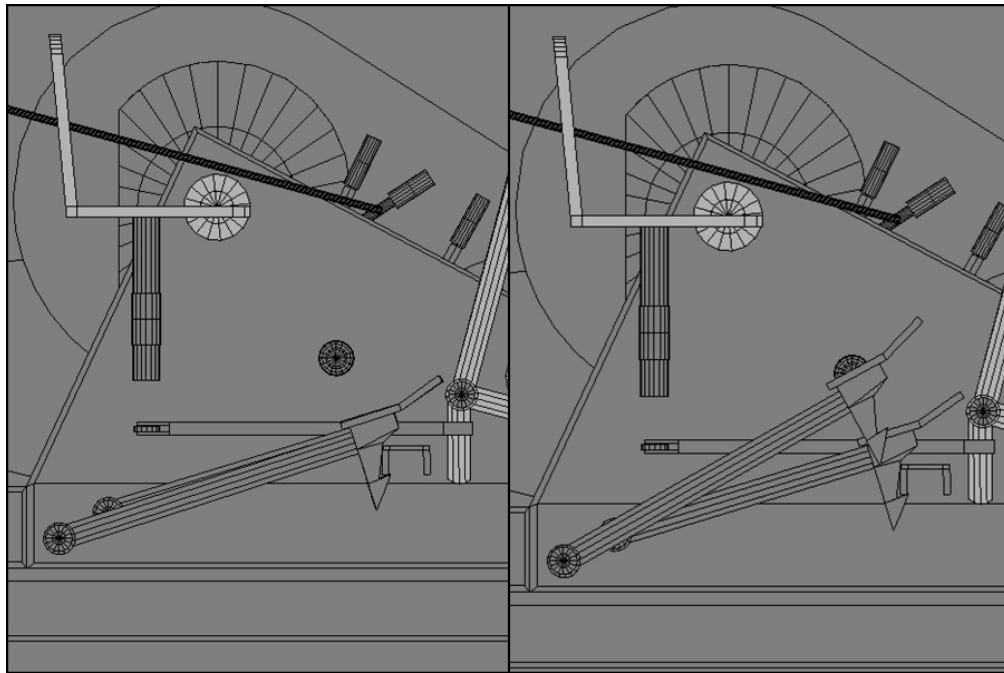
5  
6 **Figure 9.** Operation of *Athena 106* foot brake pedals (shown at bottom of both  
7 illustrations). On the left, both pedals are engaged (depressed) and latched in place by  
8 the fixed steel piece shown pressing on a triangular section at the bottom of the pedals.  
9 On the right, the front pedal is released and the back pedal is still engaged. To release  
10 the pedal, the operator would push down on the pedal and twist the latch out of place,  
11 allowing a spring to raise the pedal. Objects in white are the operator's seat (upper left)  
12 next to a round bearing for the upper winch, and the hand friction control lever (lower  
13 right) that could be used to brake the winch if the foot pedals disengaged.

16 The brake pedal for the aft spud was found elevated in relation to that of the brake  
17 pedal for the forward spud. Investigators noted a 3/32-inch indentation on the leading  
18 edge of the fixed steel piece to which the brake pedal latched. No further wear was found  
19 on the underside of the fixed piece. On the brake pedal, the latching mechanism displayed  
20 no wear.

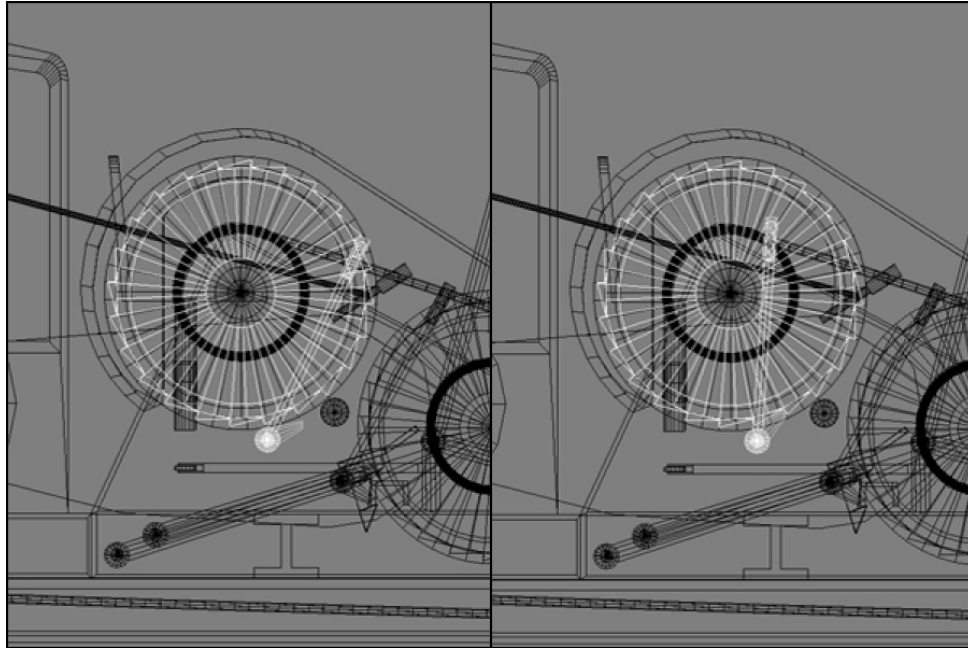
**Figure 10.** Operation of the winch pawl on the *Athena 106*. Both winch drums are shown. The white ring on the upper drum (which controlled the aft spud) is a ratcheted gear bolted to the outside of the drum. The operator engages or disengages the pawls using the lever, shown in white, that extends downward across the gear. The pawl is the tongue-shaped piece at the bottom of the lever. When disengaged (left illustration), the pawl is outside the gear teeth, allowing the gear to move freely in either direction. When engaged (right illustration), the pawl falls into the spaces between the notches so the gear can move in only one direction. (See **figure 8** for location of pawl lever at operator's station.)

21 Both the upper and lower winch drum hand friction control levers were found  
22 disengaged. Both spud winch drum pawls were found in the disengaged position. The

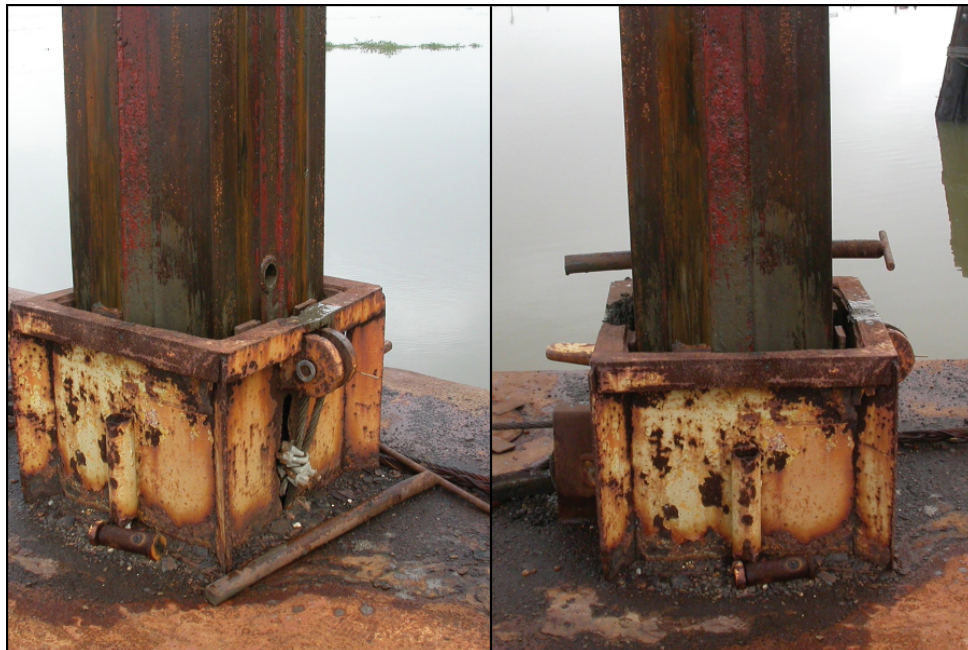
**Figure 11.** Photos showing spud with securing pin lying alongside (left) and with securing pin inserted (right).

1 spud winch's fuel tank, integral with the winch frame, was split open and deformed by  
2 the fire's heat. The 36-inch-by-2-inch spud securing pins were found lying next to their  
3 respective spud bases, not inserted into the spuds.

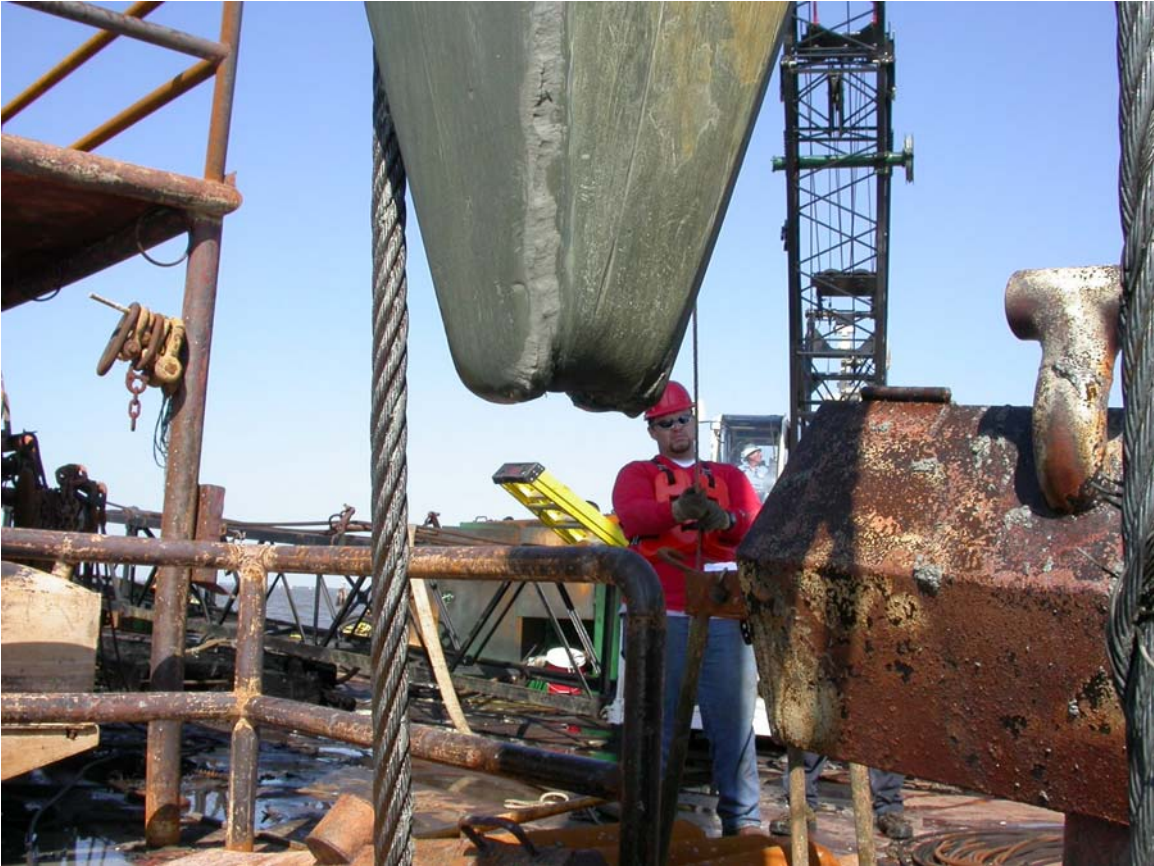
10 The deck end of the aft spud cable was cut and marked. The crane on the salvage  
11 barge pulled the *Athena 106* aft spud out of the water for examination. According to  
12 markings on the spud and measurements taken at the scene, the lower end of the spud had  
13 been submerged in the mud an estimated 17 feet. The cable, sheave, and deck pulleys  
14 were found to be in good working order during the recovery. The 4-inch tip of the aft  
15 spud displayed a slight concavity (**figure 12**).

**Figure 12.** Aft spud of the *Athena 106* when raised after it had released from its fully raised position and hit a submerged, buried high-pressure natural gas pipeline.

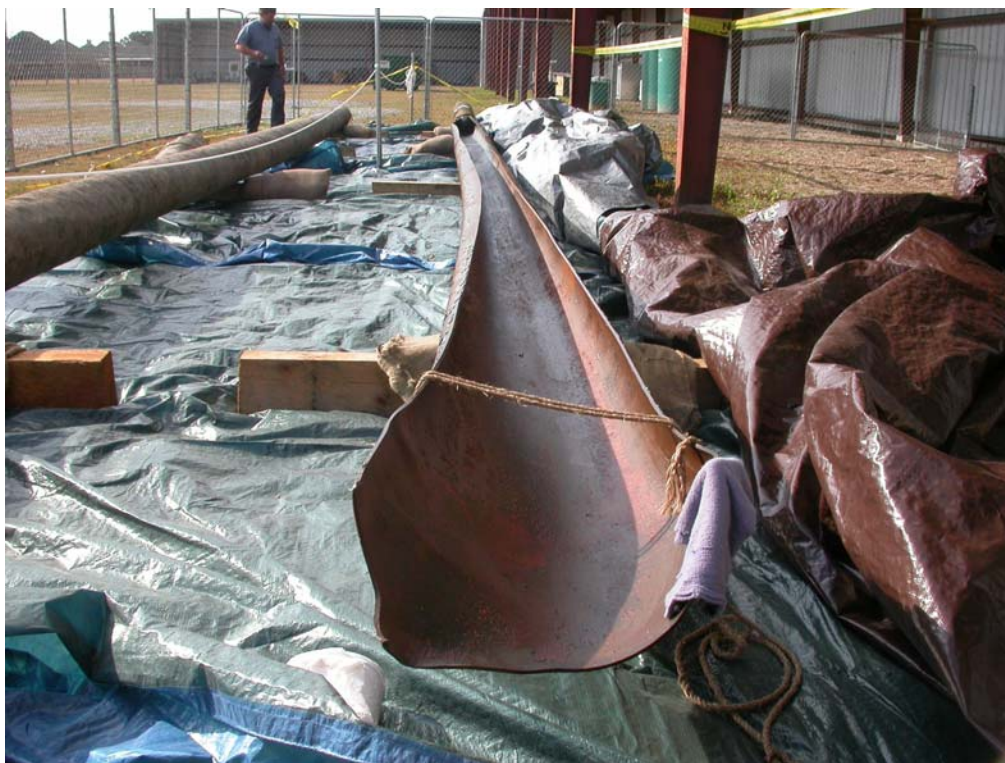
Athena Construction hired a diving company, River Services Company, to examine the underwater damage on October 13-14, 2006. The River Services Company report states: “The west side of the 6-inch [8-inch]<sup>11</sup> pipeline is making contact with the spud” and “the aft spud apparently made contact and cut a 6-inch [8-inch] pipeline.” Chevron then contracted to have the pipe recovered. Two lengths of pipe, an east piece and a west piece, each approximately 50 feet long, were recovered from each side of a transverse (circumferential-like) fracture (**figure 13**) on November 17, 2006. After a Safety Board investigator photographed the damaged pipe, it was sent to Stress Engineering Services for analysis (see “Tests and Research” section).

**Figure 13.** Fracture on the east piece of the ruptured pipeline.
